DRAFT
Specific Site Assessment for
Coal Combustion Waste
Impoundment at PacifiCorp
Energy, Wyodak Power Station
Gillette, Wyoming

December 2010
Project 092884

Assessment of Dam Safety at Coal Combustion
Waste Impoundments
Wyodak Power Station

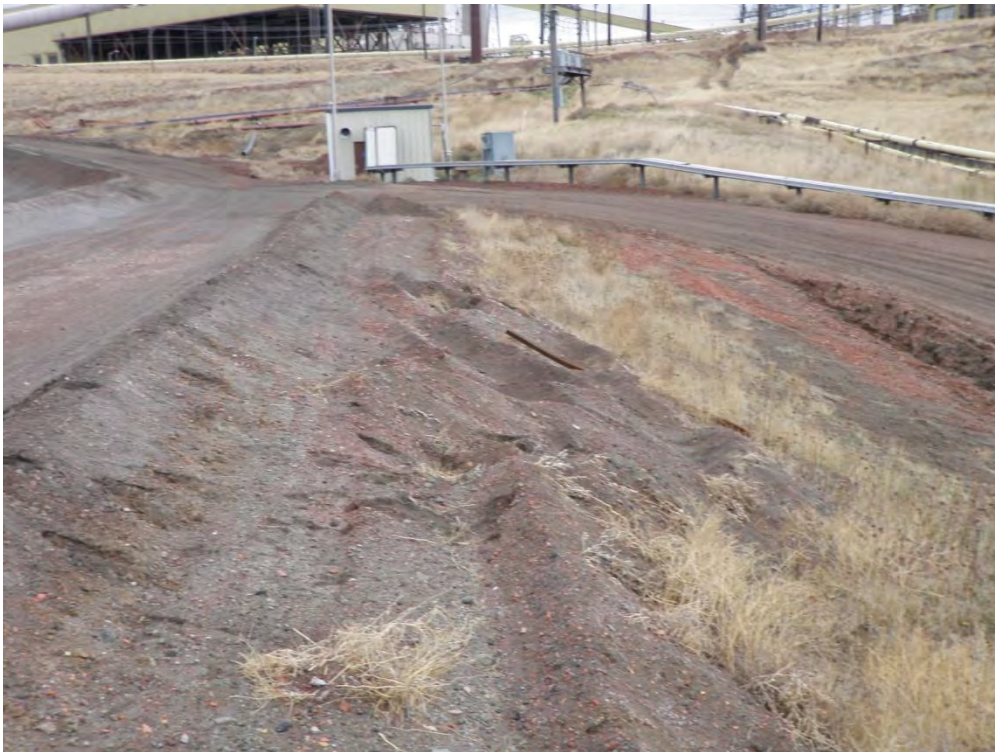
Photo 18: Southern divider dike downstream slope northeast corner near pumphouse showing man-made slump features from road grading.

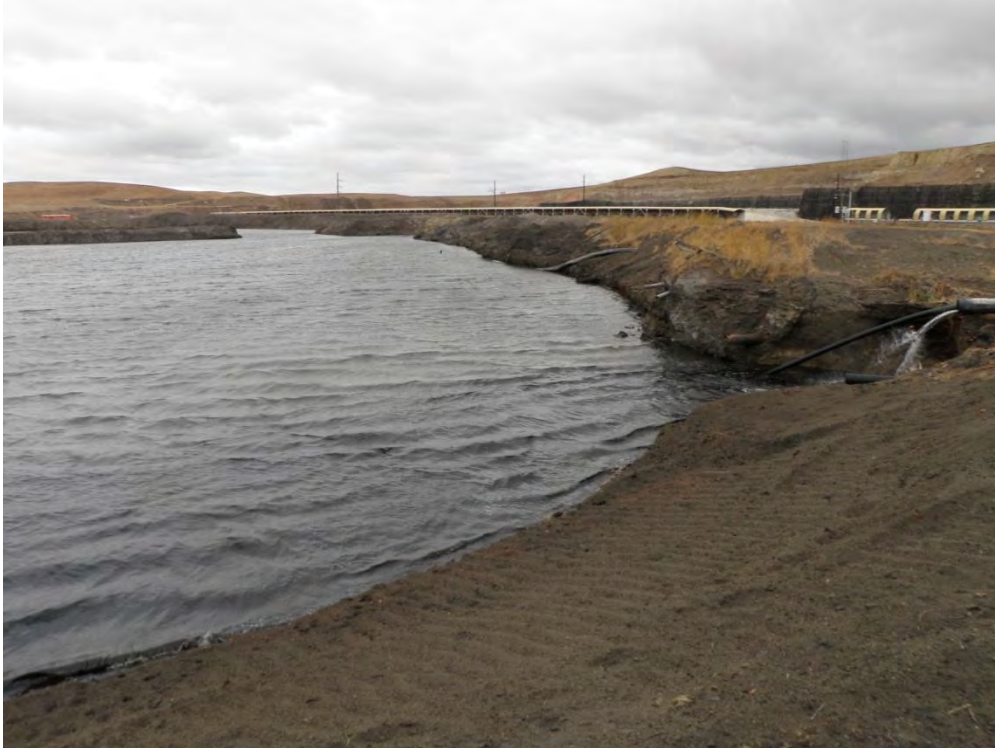
The upstream slope of the dam was generally exposed earth with sparse vegetation and a slope ranging from 2H:1V to 1H:1V. The 1H:1V upstream slope is significantly steeper than the 1989 Ash Pond enlargement design slope of 3H:1V. It is unknown if the embankment was intentionally constructed at this slope, or if the slope is a result of excavation operations to remove CCW from the pond. However, no scarps, sloughs, depressions or other indications of slope instability or signs of erosion were observed on the upper 5 feet of the upstream slope. The lower 25 feet of the upstream slope was submerged by the pond contents and could not be observed.

At 1H:1V, the upstream slope is considered to be over-steep for clay/silt embankment materials. As a result, the slopes are expected to be at risk for localized, surficial slope failures, resulting in slumps, sloughing and other forms of slope instability. These localized slope failures will adversely impact the overall embankment stability if they extend into the theoretically stable prism described in the previous paragraph. Failures of steep slopes can be induced by excavation activities such as are conducted for removal of CCW wastes from the pond. These activities include, but are not limited to, direct excavation of materials at or near the slope and undercutting of the toe of the slope. Failure of the upstream slope could pose a safety risk to personnel performing excavation and hauling operations, and to vehicle operators traversing the embankment crest.

Photo 25: North embankment dam upstream slope looking west. Settling cell on left. Inlet pipes in foreground.

Conduct regular visual observation of the upstream slope of the North Embankment Dam for sloughing, localized slope failures or other indications of slope instability. Repair upstream slope promptly upon discovery of any slope failure.

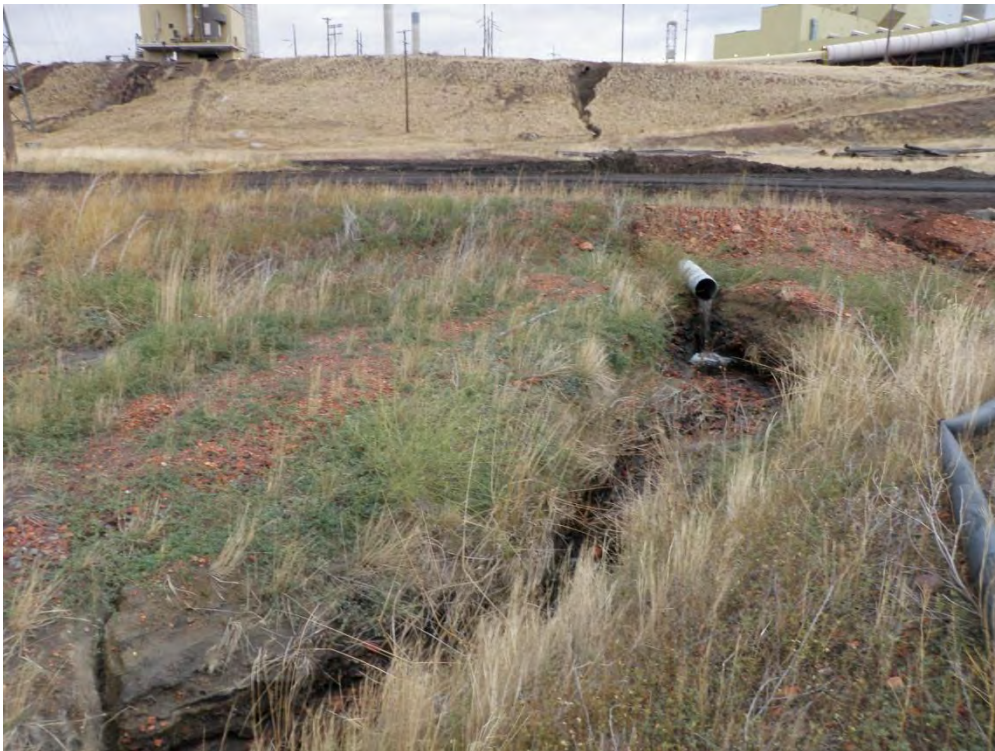
Photo 26: Inlet pipe discharging onto ground at northeast corner of settling cell.

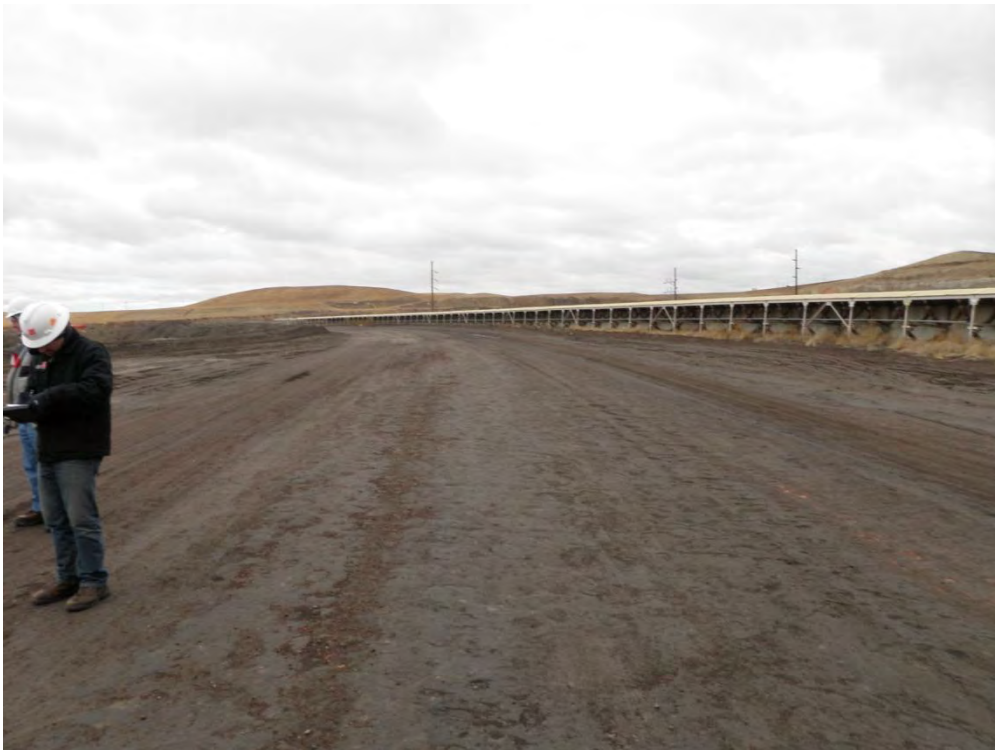
The crest of the north embankment dam appeared to be in good condition. No signs of cracking, settlement, movement, erosion or deterioration were observed during the assessment. The current minimum crest width is approximately 100 ft., and the surface is generally composed of road base material that traverses the length of the dam for vehicle access.

Photo 28: North embankment dam crest looking west.

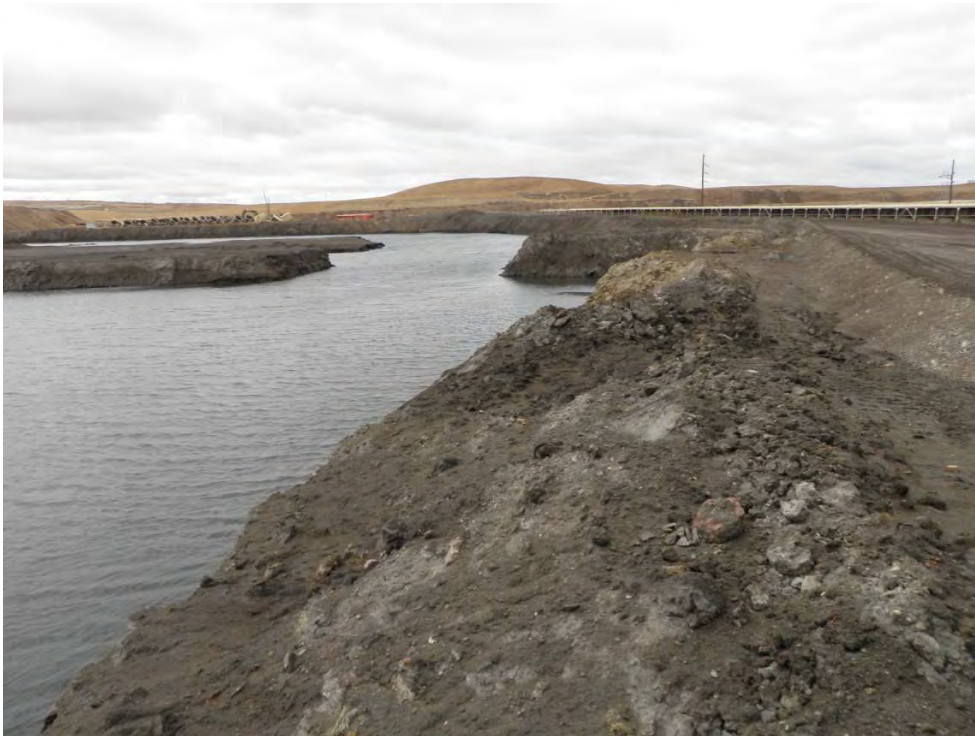
Photo 29: North embankment dam upstream slope looking west. Settling cell “heavy ash” section on left.

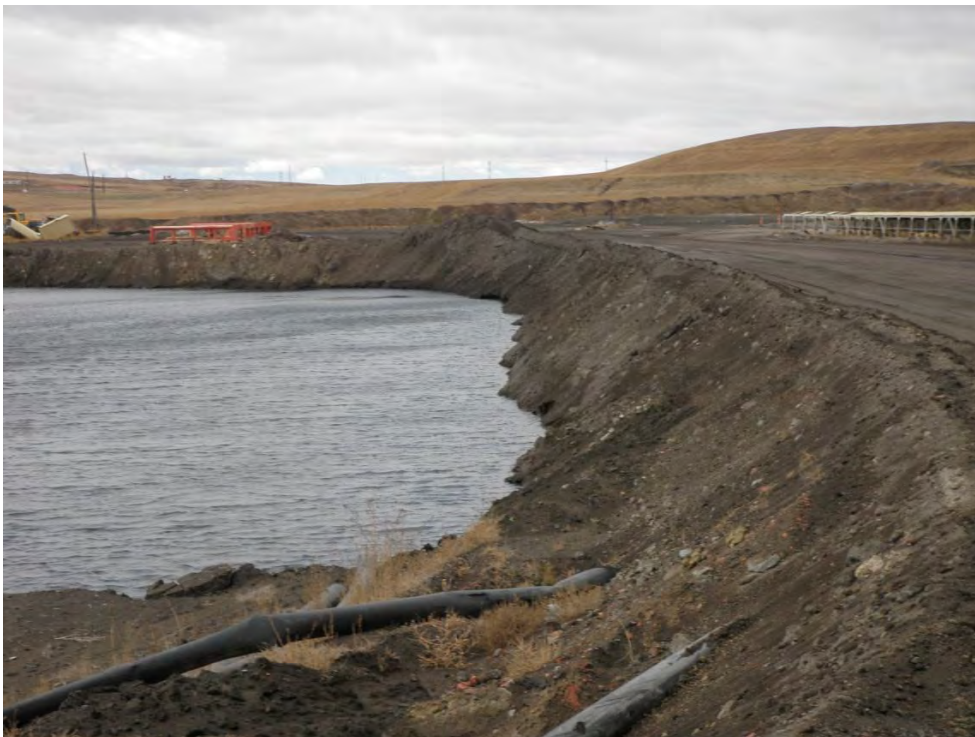
Photo 30: North embankment dam upstream slope looking west. Settling cell “light ash” section on left.

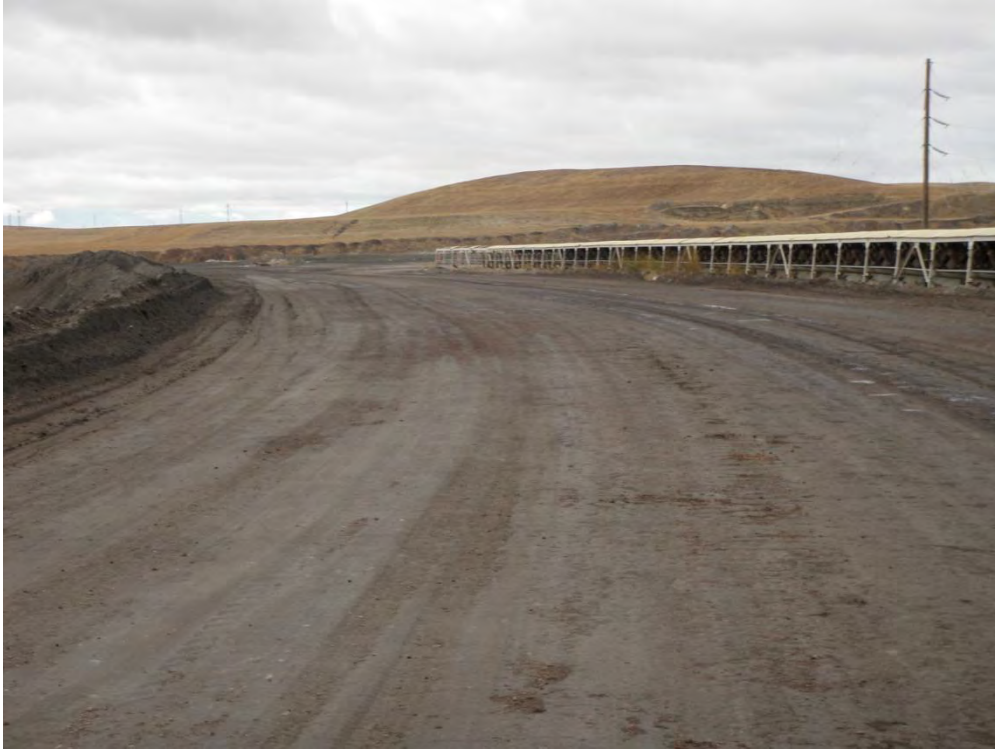
Photo 31: North embankment dam crest looking west.

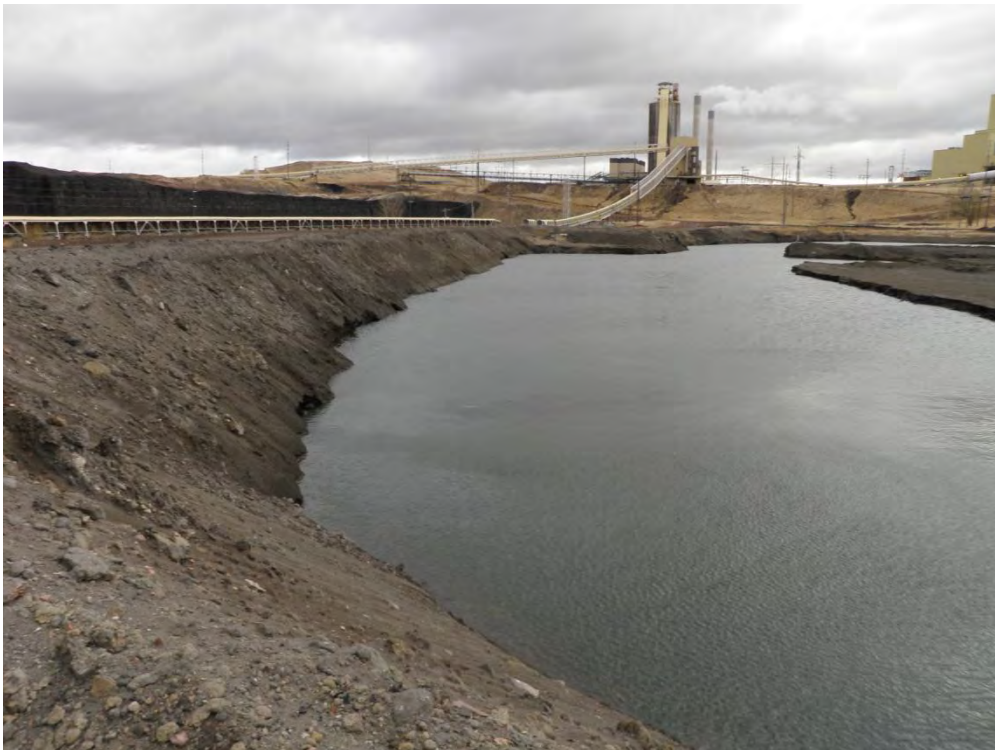
Photo 34: Northern perimeter embankment dam upstream slope looking east. Settling cell “light ash” section on right.
